Dell™ Networking

N2024/N2024P/N2048/N2048P/N3024/N3024F/N3024P/N3048/N3048P

Upgrading Dell™ Networking N2000/N3000 Series Switches to 6.3.2.7 Firmware

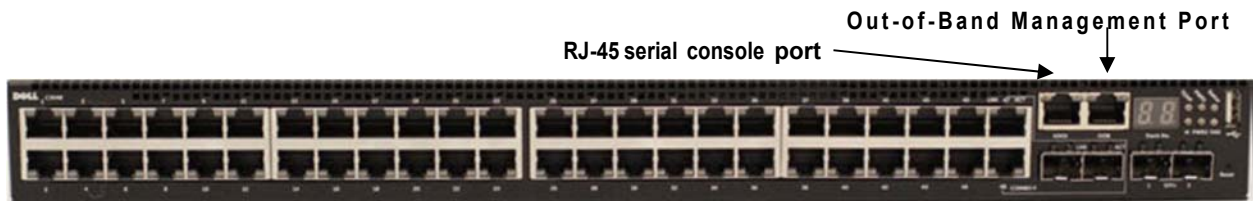
- 📌 **NOTE:** How to access serial console of the N3000 Series switch? Use a supplied “RJ45 Yost to DB9 serial cable” to access the serial console. Connect the RJ45 end of the cable to the RJ45 serial console port and the DB9 connector to your PC. Download and Install the terminal emulation software on your PC (for example, PuTTY) to access the serial console with the correct settings (default setting 9600 baud, 8 data bits, no parity bit, 1 stop bit, and no flow control).

Figure.1 N3048 with 48 10/100/1000BASE-T Ports (Front Panel)

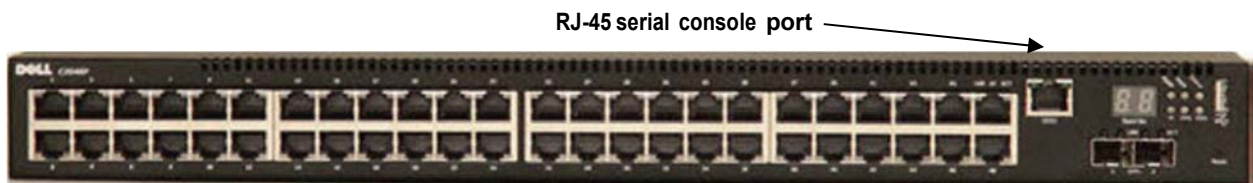
- 📌 **NOTE:** How to access serial console of the N2000 Series switch? Use a supplied “RJ45 Yost to DB9 serial cable” to access the serial console. Connect the RJ45 end of the cable to the RJ45 serial console port and the DB9 connector to your PC. Download and Install the terminal emulation software on your PC (for example, PuTTY) to access the serial console with the correct settings (default setting 9600 baud, 8 data bits, no parity bit, 1 stop bit, and no flow control). N2000 switches do not have an out-of-band interface.

Figure.2 N2048 Switch with 48 10/100/1000BASE-T Ports (Front Panel)

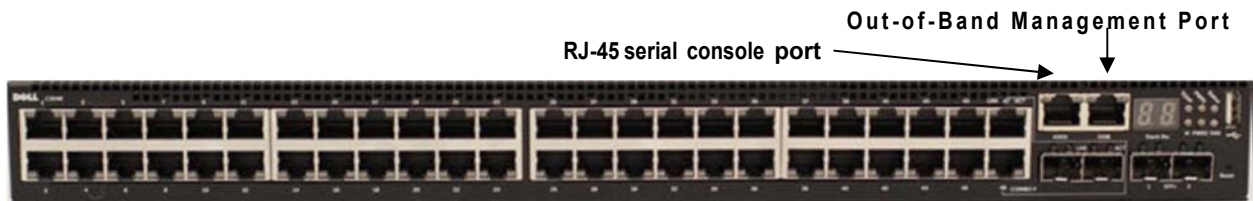
1. Connect a serial cable to the serial console port on the switch (8-No Parity-1-9600-No Flow Control).
 - a. Use the supplied RJ45 Yost to DB9 serial cable. Connect the RJ45 end to the switch console port and the DB9 connector to your PC. Set the terminal emulation software (for example., PuTTY) to the correct settings (default setting 9600 baud, 8 data bits, no parity bit, 1 stop bit, and no flow control).

Figure.3 N3048 with 48 10/100/1000BASE-T Ports (Front Panel)
